Contractor BUNTE renovates flow control structures on the river Main

RENOVATION WORK IN VIERETH

Using an excavator with a drum cutter attachment from KEMROC

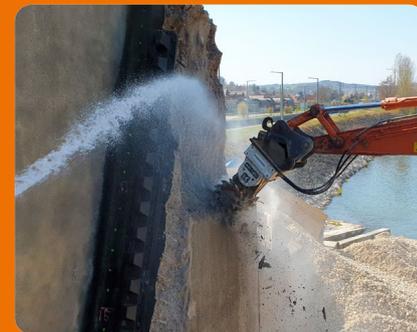
A KEMROC drum cutter working on the river barrage at Viereth on the Main. During renovation, the shape of the concrete pillars had to be changed.

of the new lifting mechanism, the concrete pillars had to be modified before the new mechanisms could be concreted in place. For the removal of the concrete it was decided that a KEMROC KR 120 rotary drum cutter mounted on a 35-ton excavator would be the ideal tool combination. It met the contractual specifications while promising to meet financial requirements.

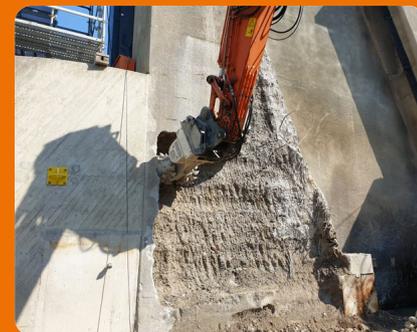
Removing concrete from the central pier. The upper section remained untouched while a 1.6 m deep layer was removed from the lower section.

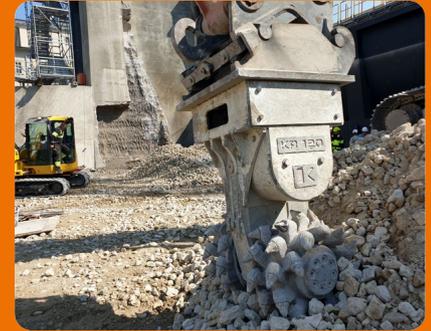
The KEMROC KR 120 in close-up. While working in unreinforced concrete, wear on the picks was minimal.

proved to be a little too small and underpowered for the conditions. According to the site manager, the performance of the larger drum cutter was much better, "The drum cutter was perfect in terms of performance, precision and gentle cutting action. It ran smoothly from start to finish." A total of 270 m³ of concrete was removed from the two piers at an average rate of 10 m³ per hour. "Pick consumption was within acceptable limits," explained Christoph Karsch, "and the cutter met little resistance in the plain concrete. We only saw any significant wear in some lightly reinforced areas and on the granite pillar bases."

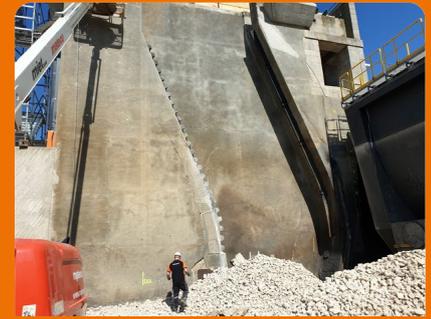
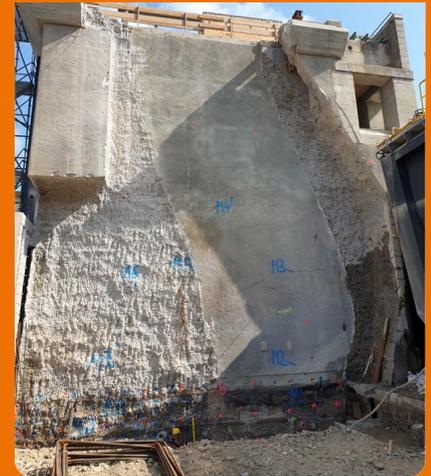
A general view of the central pillar. On the top, the original pillar before work began. On the bottom, the pillar after work was almost complete.
